Field Report for Airborne Data Collected In Support of US EPA Region 6 South 4 Group Fire 03 December 2019

The US EPA Region 6 requested that the ASPECT system be deployed to provide monitoring support beginning on 27 November 2019. This report summarizes findings observed during the two missions flown on 03 December 2019.

Flight Results for Flight 12, 03 December 2019

Flight Results for Flight 13, 03 December 2019

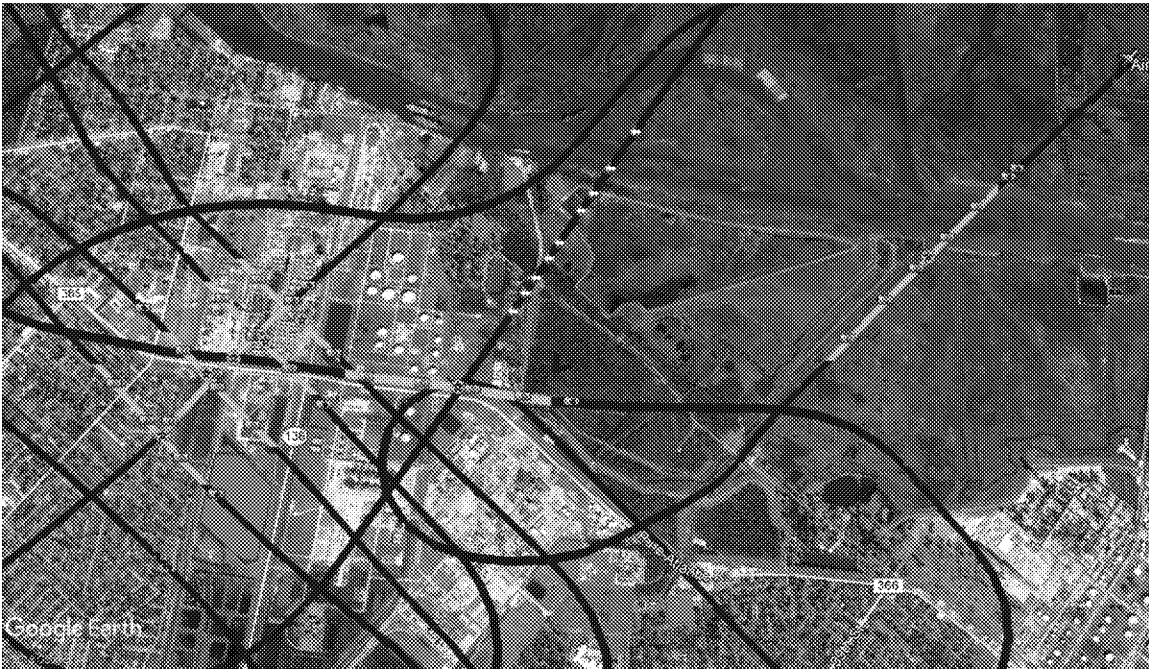
Figure 2: Data collection passes, Flight 12, South 4 Group Fire, Port Neches, TX. The blue lines represent the ASPECT flight path, green lines represent when the FTIR was actively collecting data, the yellow icons with star is the centroid of the line scanner image, and the camera icons represent when a photo was taken.

The order to launch flight 12 was given at 0700 central on 3 December 2019 with the aircraft reporting wheels up at 0722. The initial data collection run over the site was at 0752 (central) The aircraft made a total of 8 data collection passes; flight information is summarized in Appendix Flight #12 and Figure 2.

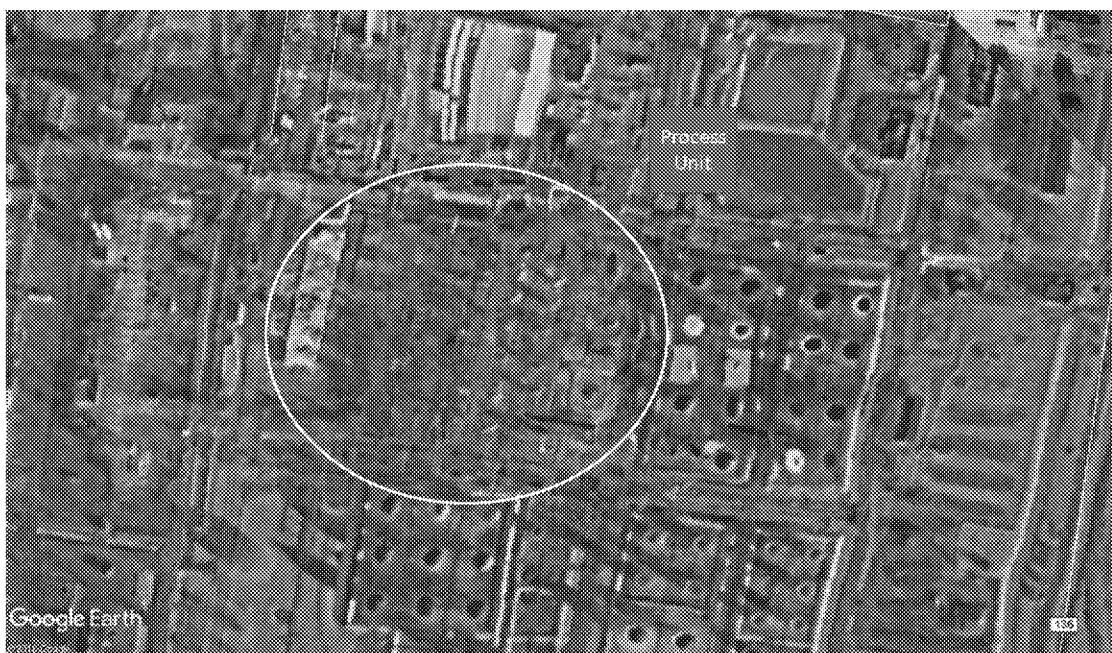
A total of 2 test and 7 data collection passes were made in the proximity of the fire and an infrared line scanner image was generated for each pass. Figure 3 shows a typical 3-band infrared image obtained from data collected for Run 3. The thermal environment of the unit is low. At the time of the IR collection, no water cannon or emissions can be seen in the image. Figure 4 shows a close-up thermal analysis of the production facility again showing a flat thermal environment in the unit.

Figure 4: -- 3 band IR Image, Flight 12, Run 6, South 4 Group Thermal Image

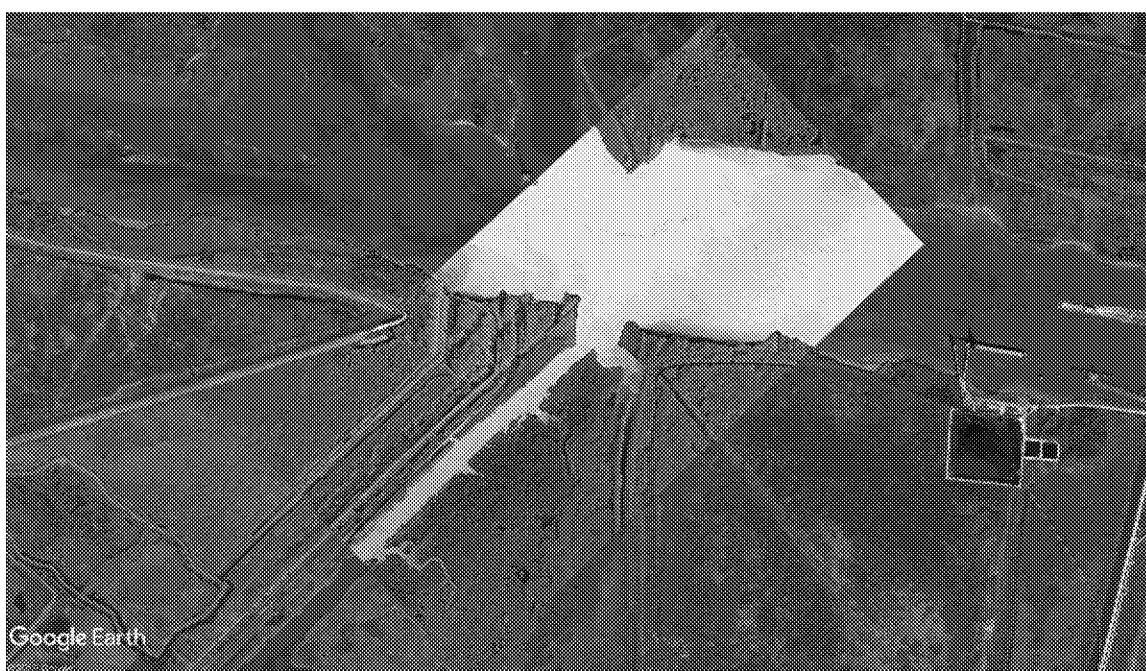
As part of the flight mission, ASPECT was flown along a waterway leading from the east side of the facility to the Naches River. Figure 5 show an IR image of the waterway flowing into the River. No sheen can be seen in the image.

Figure 5: -- 3 band IR Image, Flight 12, Run 10, Waterway Image, South 4 Group Fire

analysis of imagery. There were no chemical detections in the proximity of the facility. Analysis IR imagery of the junction of the waterway east of the facility which intersects with the Naches River showed on evidence of oil sheen.

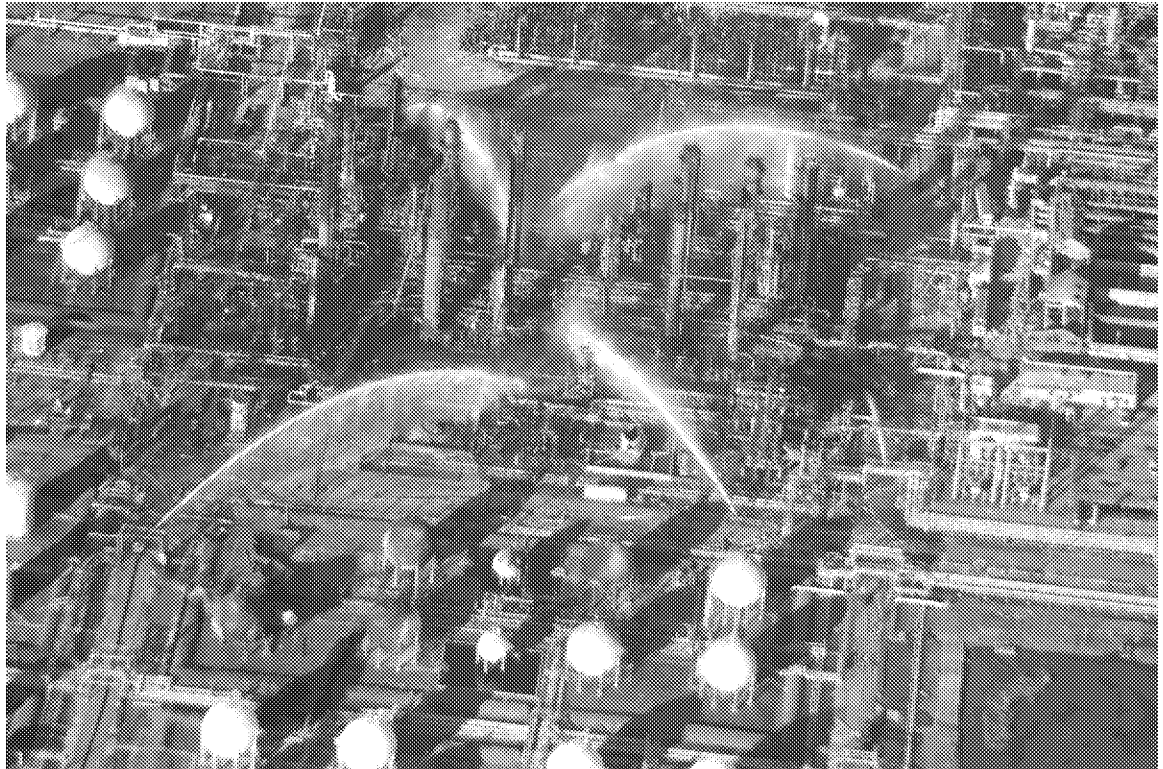
A full set of high resolution aerial digital photography were collected as part of the flight. Figure 6 shows a representative image collected as part of each pass. Smoke is not evident in the image and only one water cannon can be observed being directed into the north part of the unit. No fire was observed. The oblique image in Figure 7 shows that 5 water cannons were in operation with no evidence of fire or smoke generation.

Figure 7: Oblique Image of the South 4 Group Fire

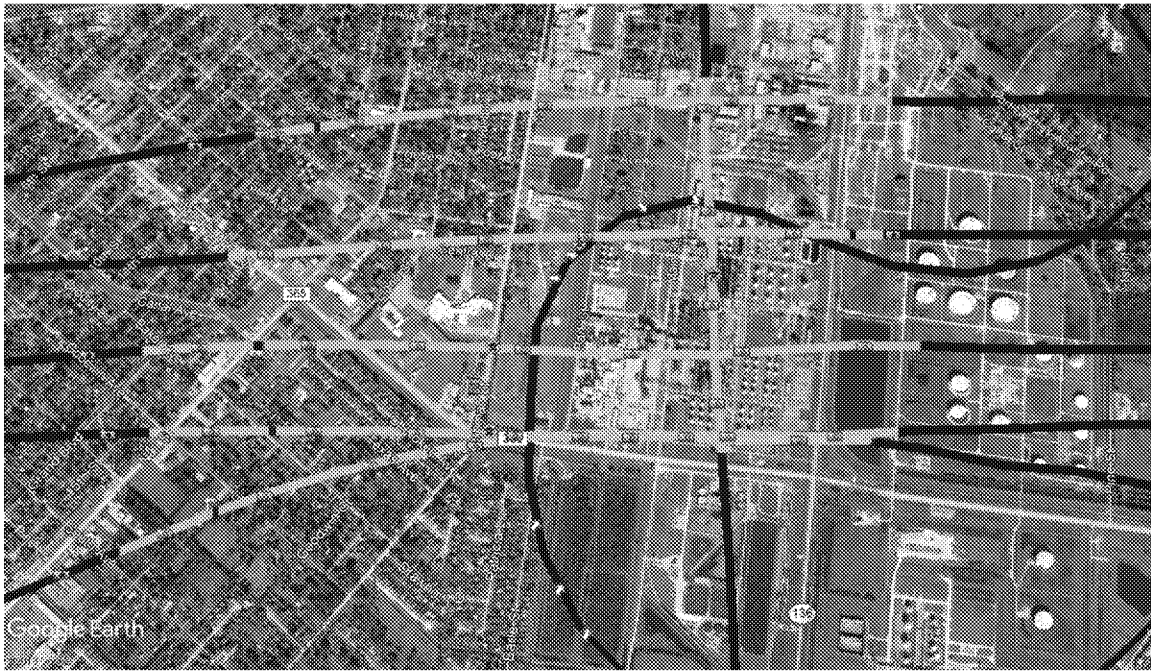
Figure 8: Data collection passes, Flight 13 South 4 Group Fire, Port Neches, TX. The blue lines represent the ASPECT flight path, green lines represent when the FTIR was actively collecting data, the yellow icons with star is the centroid of the line scanner image, and the camera icons represent when a photo was taken.

The aircraft was airborne at 1443 (central) was over the site at 1439 (central). A total of 1 test and 6 data collection passes were completed. Flight information is summarized in Appendix Flight #13 and Figure 8.

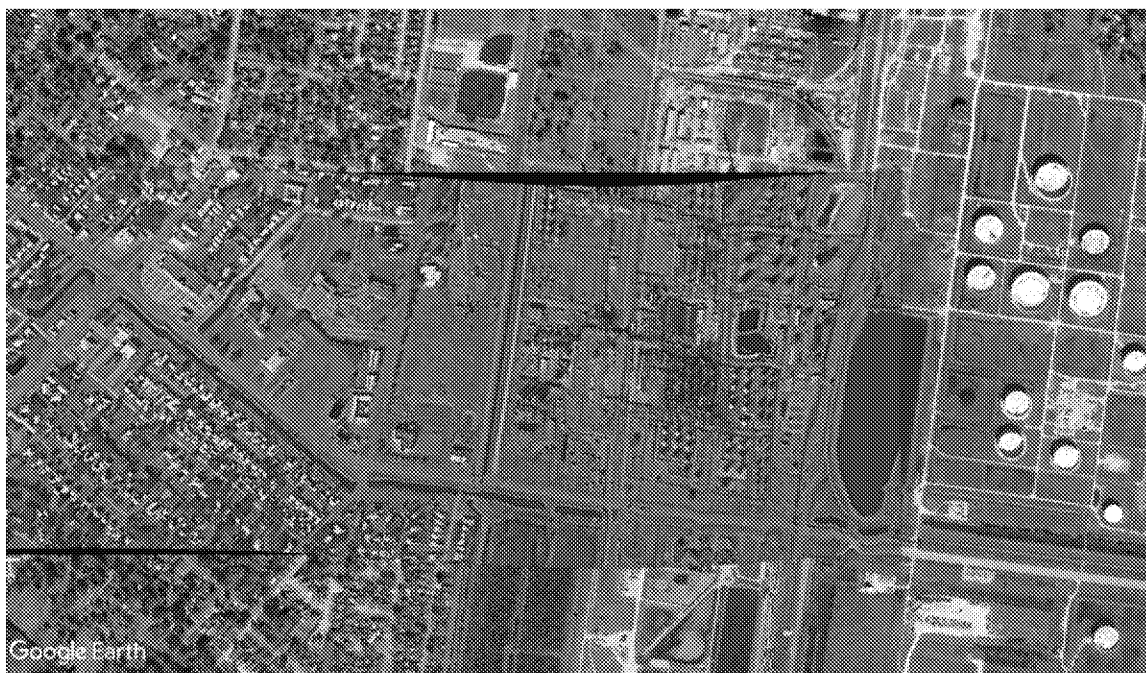
A total of 1 test and 6 data collection passes were made in the proximity of the fire and an infrared line scanner image was generated for each pass. Figure 9 shows a 3-band infrared image obtained from data collected for Run 2. Examination of the image shows no significant elevated thermal locations on this collection pass. No chemical plume was observed in the frame. Figure 10 shows a close-up of the process unit collected on Run 5. No apparent high temperature source is evident in the image.

Figure 9: – 3 band IR image, Flight 13, Run 2, South 4 Group Fire

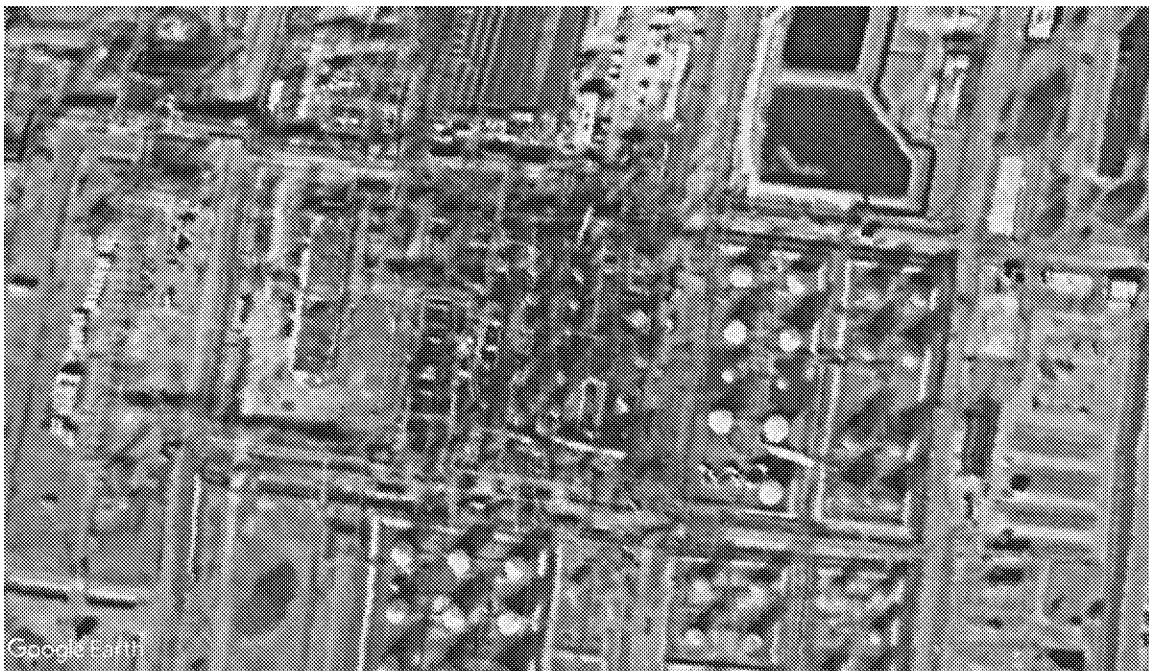
Figure 10: -- 3 band IR image, Flight 13, Run 5, South 4 Group Fire

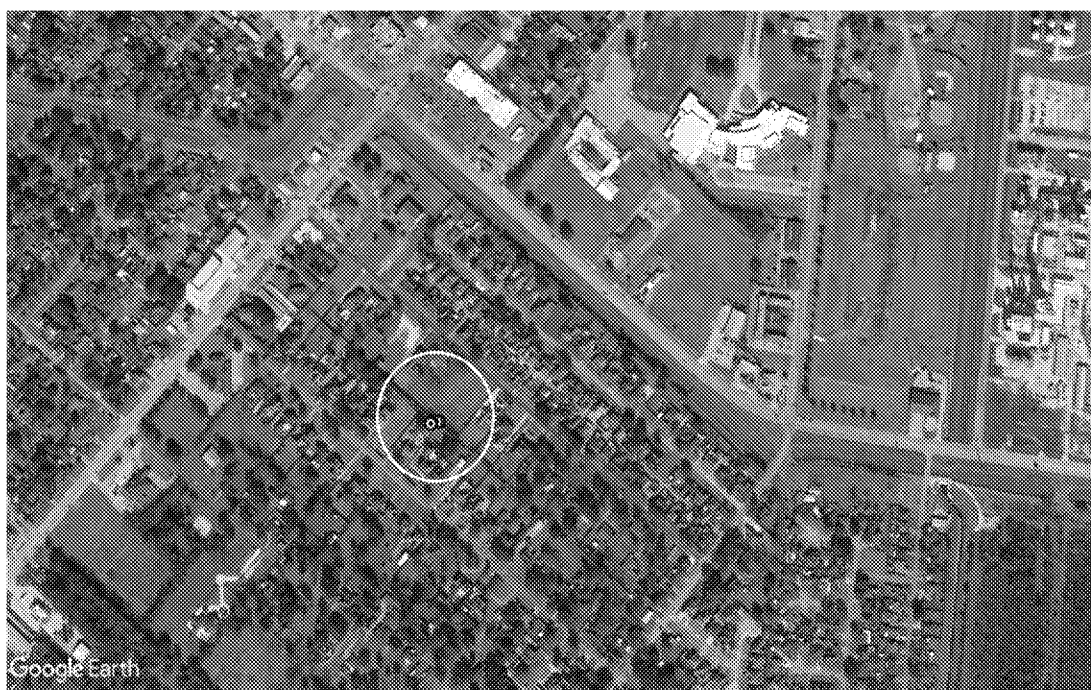
Due to reported elevated VOC levels near the community west of the facility, flight lines were extended to provide data collection over these areas approximately 1300 meters west of the facility, detections of 1,3-butadiene and aromatic hydrocarbons were detected. The location of the detection is given in figure 11. Figure 12 show a spectrum for the 1,3-butadiene detection. This is a somewhat complicated spectra since there appears to be other hydrocarbons present in the data. Within the same cluster of detection points, an aromatic such as ethyl benzene was also detected. Figure 13 shows this spectrum with strong peaks just above 700 wave numbers. Analysis of the data shows the highest concentration of 1,3-butadiene at approximately 0.9 ppm. A concentration for the aromatic is difficult since this was analyzed manually but it is estimated that the concentration is less than 1 ppm. A summary of data of the data collection is given in table 6.

Figure 11: -- 1,3-Butadiene and Aromatic Hydrocarbon Detection Locations,
Flight 13, South 4 Group Fire

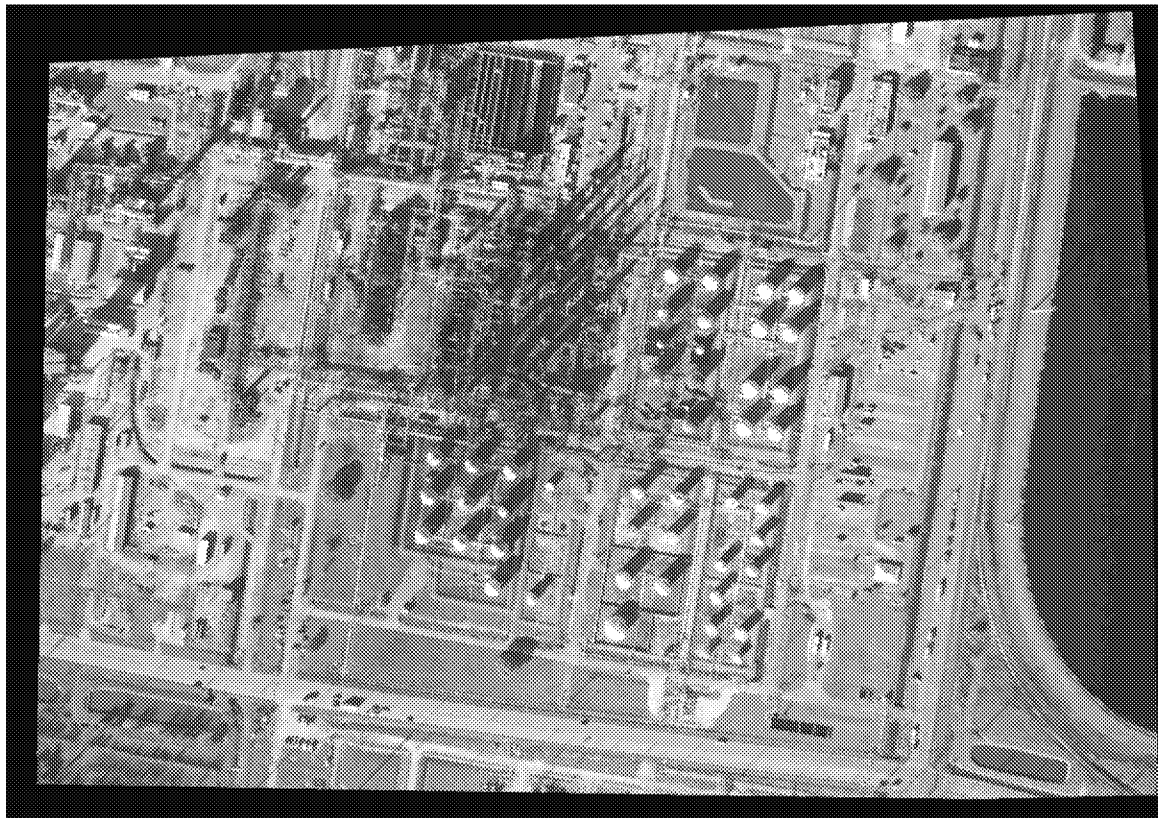
A full set of high resolution aerial digital photography were collected as part of the flight. Figure 14 shows a representative image collected as part of each pass. In a similar fashion as the morning flight no smoke was observed being emitted from the site. Oblique imagery does show that water cannons continue to be used to flood the process unit (figure 15).

Figure 14: Aerial Image of the South 4Group Fire, Flight 13

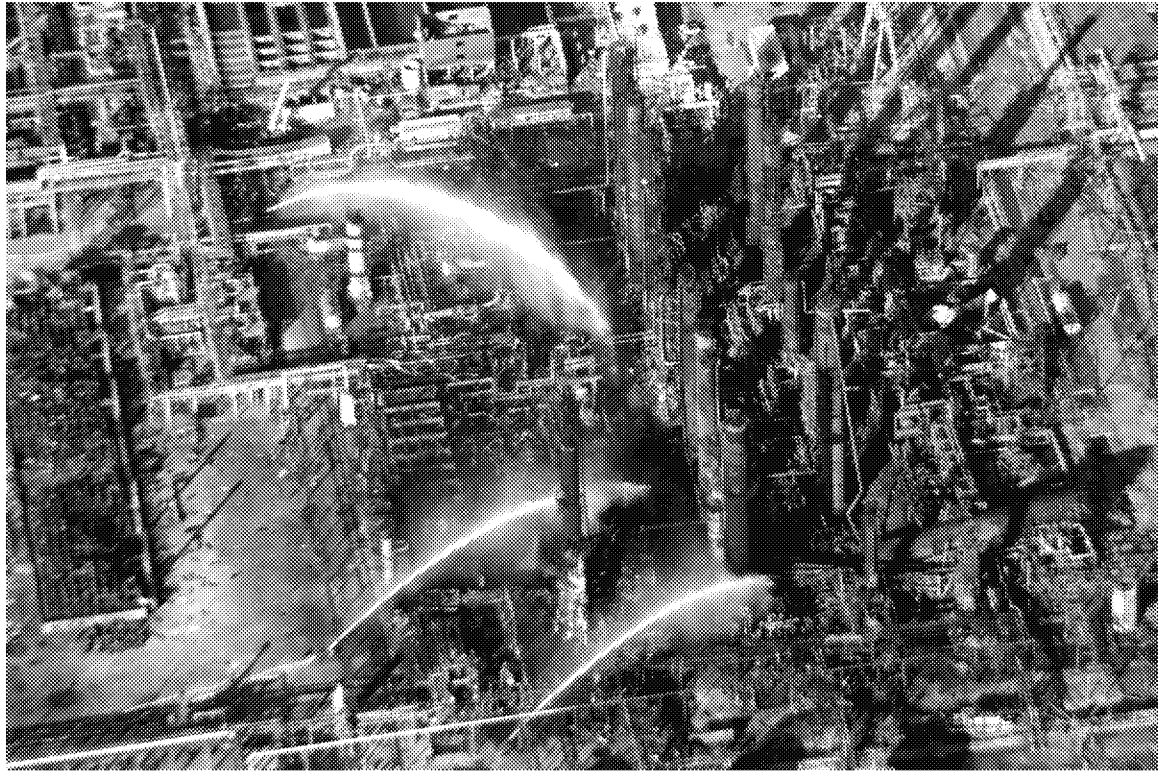
Figure 15: Oblique Image of the South 4Group Fire, Flight 13
